CLUTCH RELEASE PROBLEMS – DAEWOO

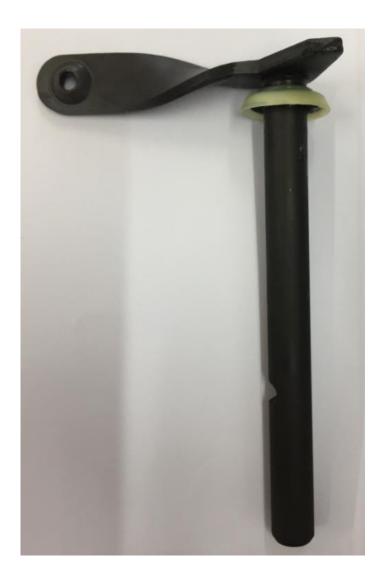
It has been found that these vehicles have an issue with the clutch release shaft bending over time causing a lack of release in these vehicles. Replacing the clutch will not improve these symptoms as the root cause is wear in the release mechanism.

If it is found that the lever is not in line with the notch then it is recommended to be replaced and these units are available for purchase and stocked under part number RSDW002
