PIVOT BALL & CLUTCH ADJUSTMENT COMMODORE [V6 & V8]

This bulletin relates to V6 & V8 Commodores fitted with MC6, MC20 & MC21 Gearboxes

Bearing Noise – Fork Rattle

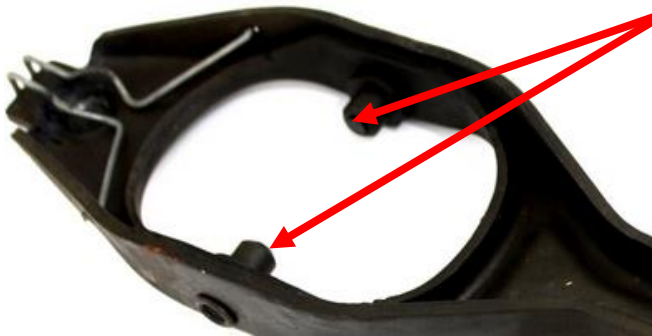
The forks in these vehicles are fitted with rubber absorbers at the contact points with the bearing.

Over time these rubber absorbers wear and the fork will then drop down and rattle against the window of the bellhousing.

BEARING NEEDS TO BE A TIGHT FIT!

With the clutch removed measure the distance from the clutch housing front face to the top of the clutch fork ball stud. For V6 engines this distance is equal to 102mm & for V8 vehicles, this distance is 105mm

With the clutch installed and the gearbox fitted, push the fork forward until the bearing just touches the diaphragm. Measure from the clevis hook on the clutch fork to the rear face of the bellhousing.

For V6 the measurement is 39mm and for V8 vehicles the measurement is 48mm
